A SURVEY OF JAPANESE SHIPYARD
APPLIED MARINE COATINGS PERFORMANCE

November 1985

John W. Peart
Avondale Shipyards Inc.

Benjamin S. Fultz
Bechtel National, Inc.
Job Number 17856

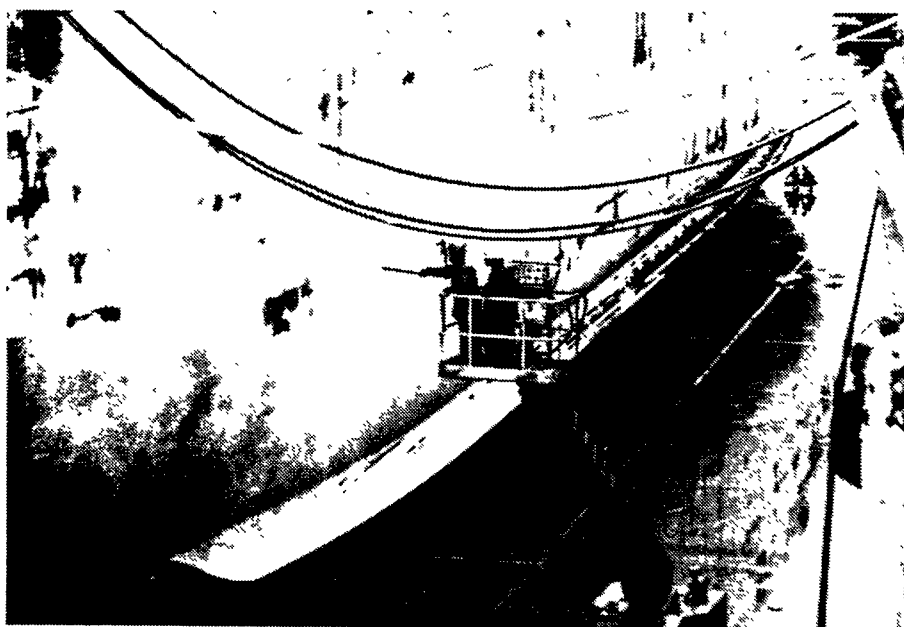
Figure 3.1: View of Foul Free Bottom

The coatings failure on the underwater hull and freeboard was primarily limited to mechanical damage resulting from anchor chains and fenders. There was no fouling except in areas where the antifouling (AF) was removed due to mechanical damage. There was no undercutting at the damaged areas. Some inorganic zinc shop primer could be seen at the edges where the coatings were removed. This finding seems to support the suitability of use of inorganic zinc primers as undercoats for immersion service; however, it must be remembered that the film thickness was limited to 0.6 mils and the material is modified with a reduced zinc loading and an organic resin. See Figure 3.1 for overall view of underwater bottom.

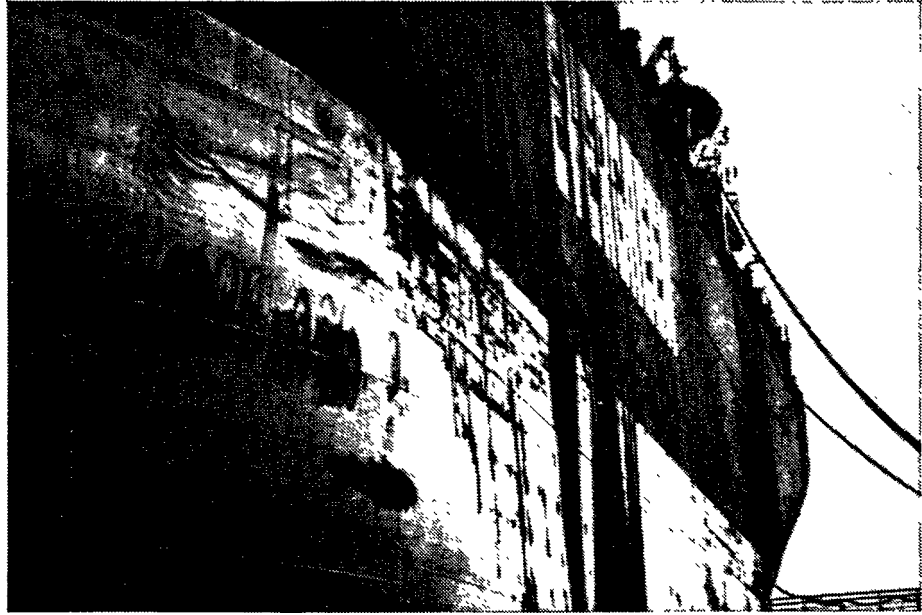
Figure 3.3: Freeboard Damage

The freeboard area coating system (modified inorganic zinc shop primer plus three coats of chlorinated rubber) was providing excellent corrosion protection where the film had not been mechanically damaged; however, in those areas where the film was ruptured, much rust could be seen. (See Figure 3.3). As would be expected, the thin film zinc shop primer was not providing underfilm corrosion protection. (See Figure 3.4) Also as would be expected, the chlorinated rubber topcoat was beginning to chalk.

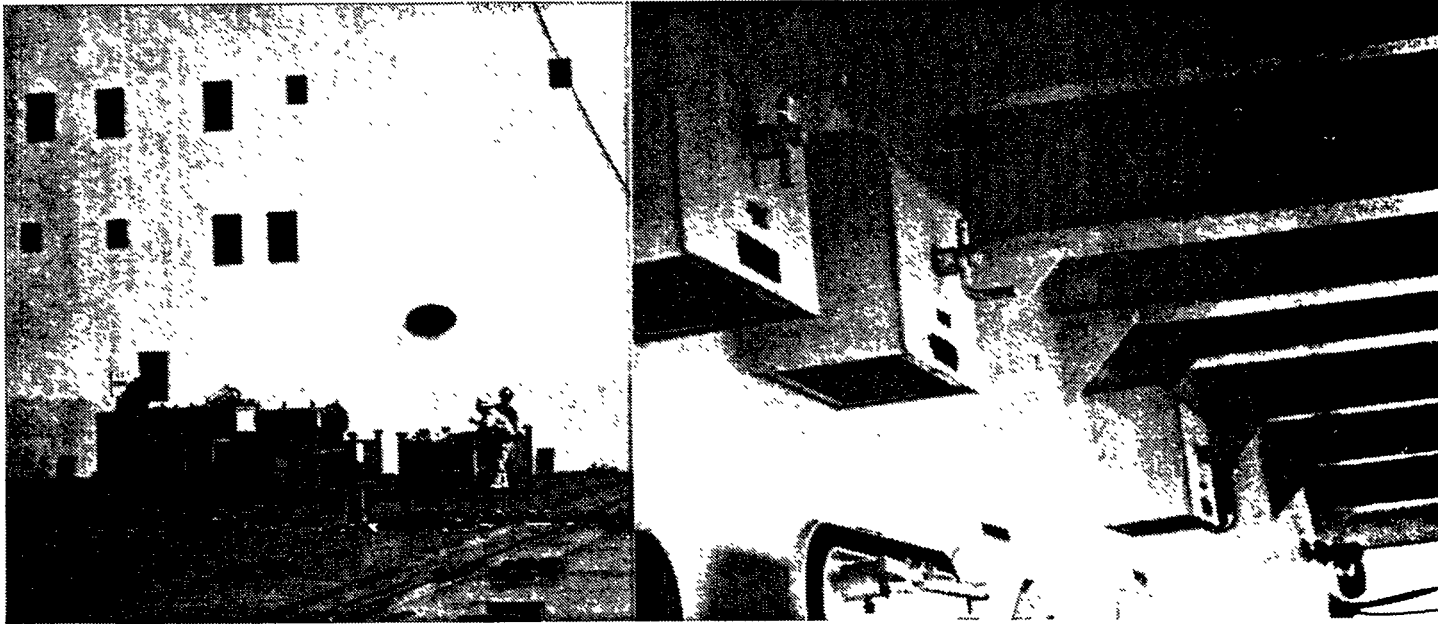
Figure 3.5: Evergiant House

The deck house was in excellent condition to include sharp edges, ventilation opening, attachments and appertenences. The deck house system consisted of an epoxy/polyurethane system. The sharp edges and some erection welds were double hand stripped prior to application of the complete epoxy intermediate coats. The overall deck house looked better than most U.S. ships that had been observed by both inspectors. The excellent condition could possibly be due to the stripping technique used. (See Figure 3.5). Some minor rust bleed was noticed on some isolated vertical weld seams on the aft portion of the deck house. (See Figure 3.6)

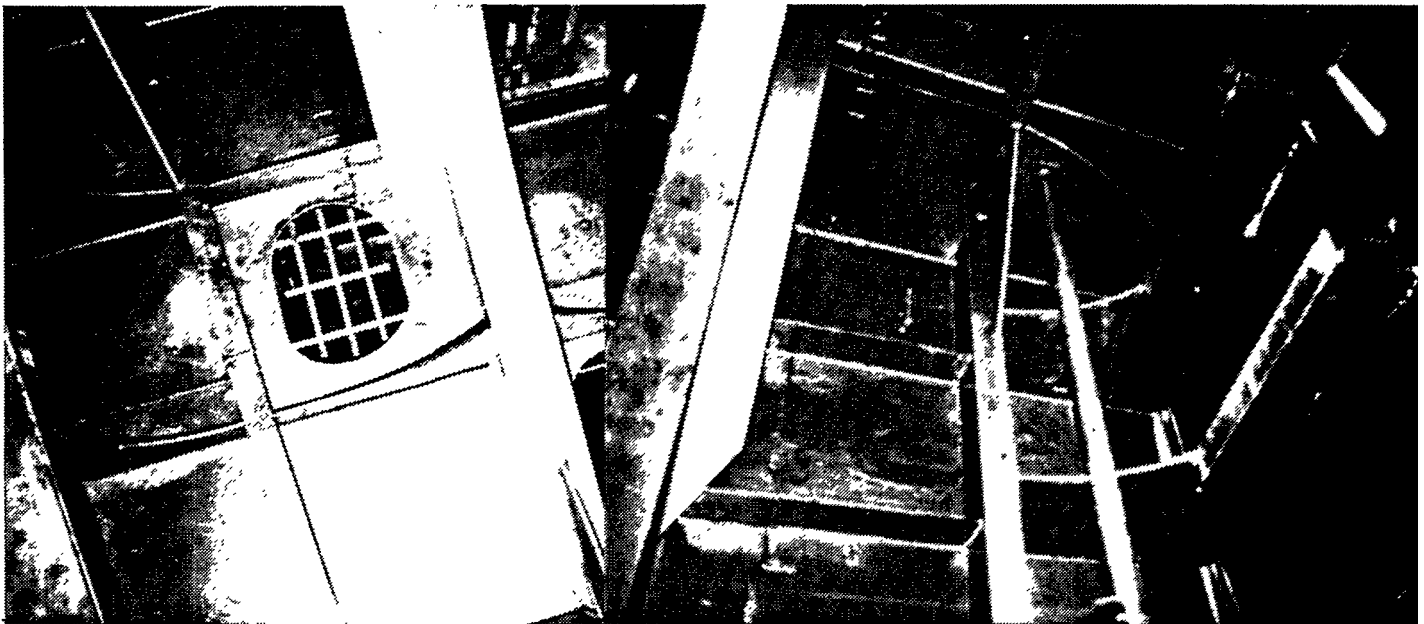
Figure 3.9: Evergiant Tank

The forepeak tank was selected for tank coating inspection. The applied system consisted of one coat of coal tar epoxy applied over shop primer. The weld and damaged areas were repaired with power grinders but no primer was reapplied to repaired areas. Swirl marks from the secondary surface preparation was visible through the coating. The actual measured thickness varied from 18 to 20 mils. The overall condition of the tank coating was good

with no blistering but with some minor failure of weld areas. It also appeared that the tank had not been fully pressed up during ballast. (See Figure 3.9) The tank coating was supplemented with one 10 to 15 pound zinc anode in each tank cell. The anodes did not appear to have been activated, therefore, exhibiting little or no consumption. This could be attributed to the anode mounting method which consisted of mechanical fastening of the round anode bar to a round "C" clamp. Rust was observed on the anode rod and the bare area of structural steel immediately around the anode. Additionally, no calcareous deposits were noted on the bare steel which would indicate the lack of electrical continuity between the anode and the steel.

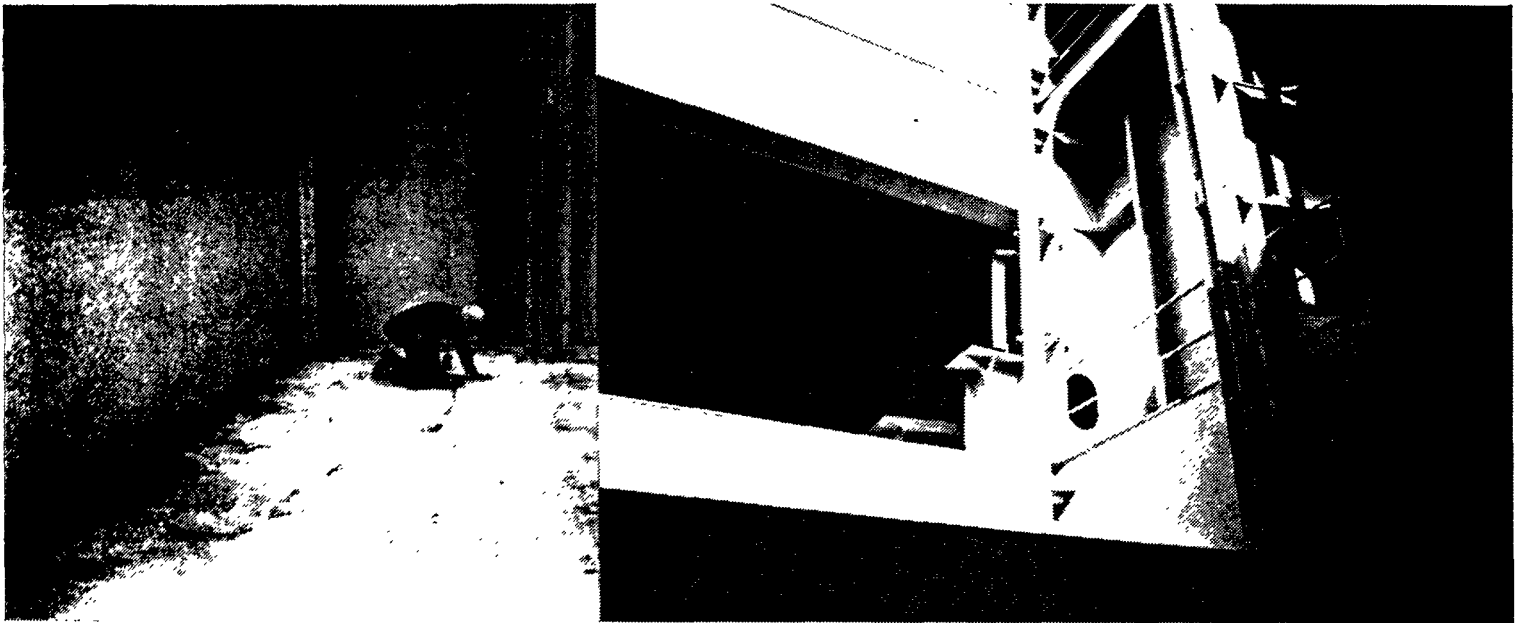
Figure 3.10: Evergiant Cargo Hold

The bleached tar epoxy system in the dry cargo holds was in excellent condition. There was some checking of the coating in areas of measured high film build - 13 mils. (See Figure 3.10) The checking did not extend to the steel substrate. The condition of the alkyd system in the Forecastle area was also excellent with no failure.

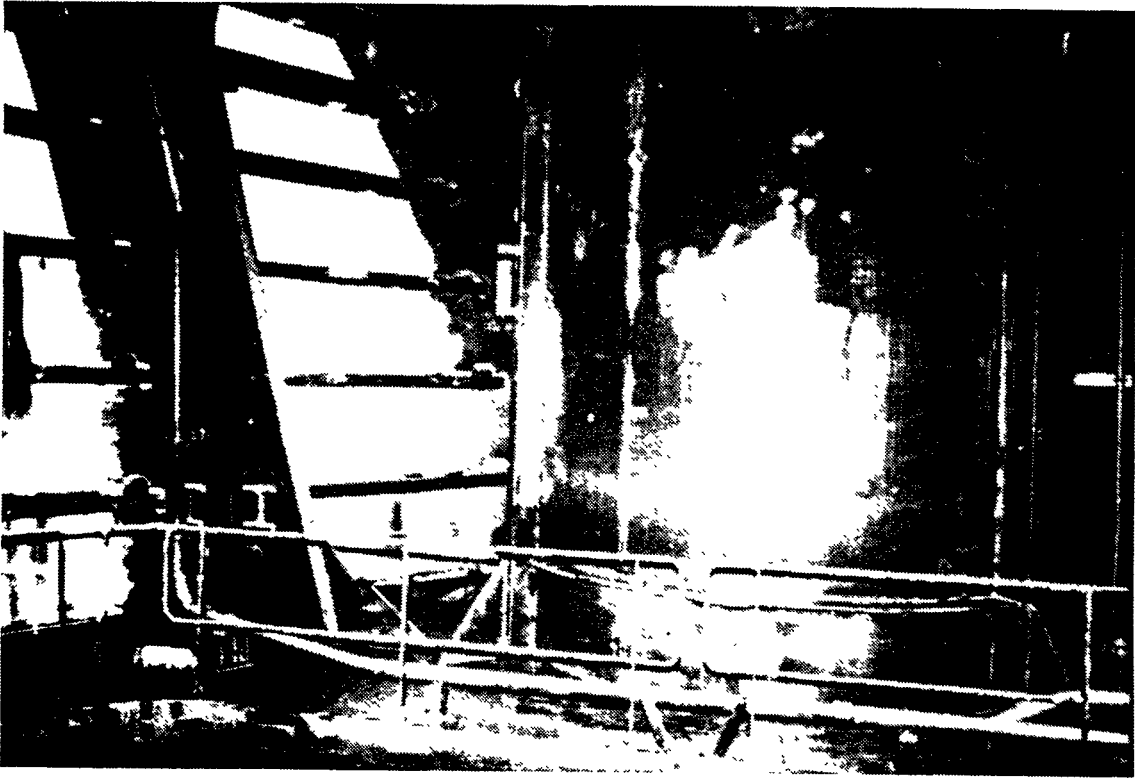
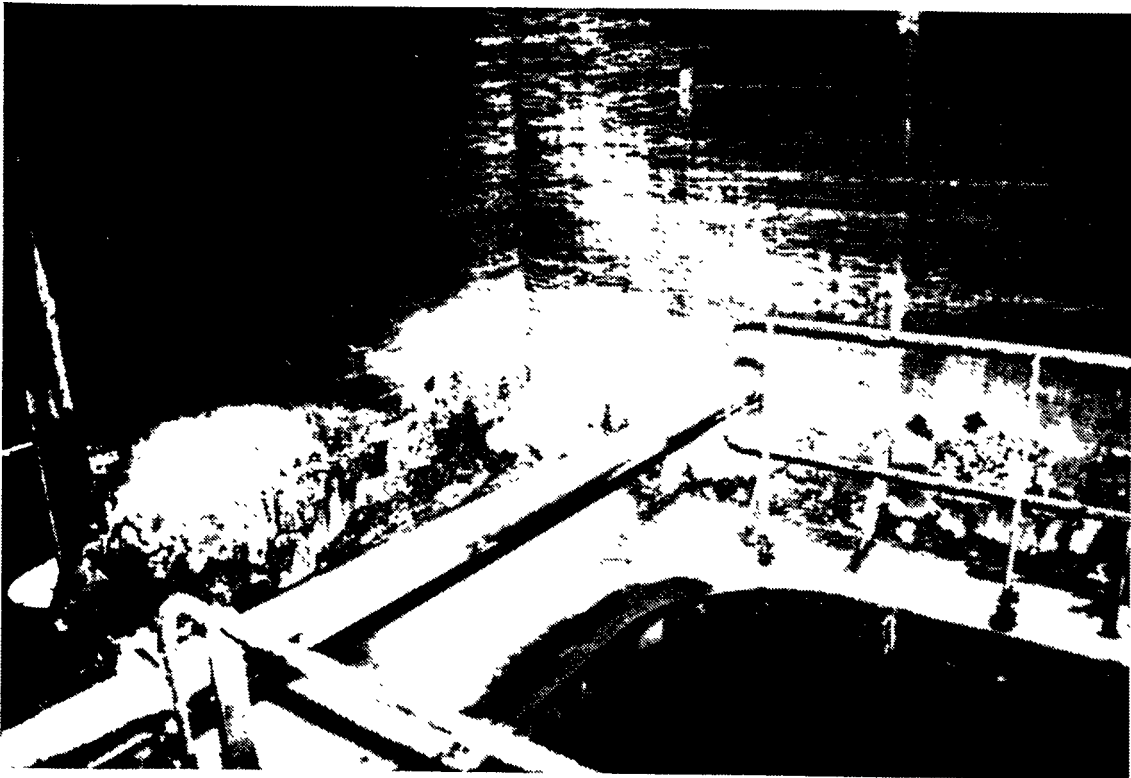
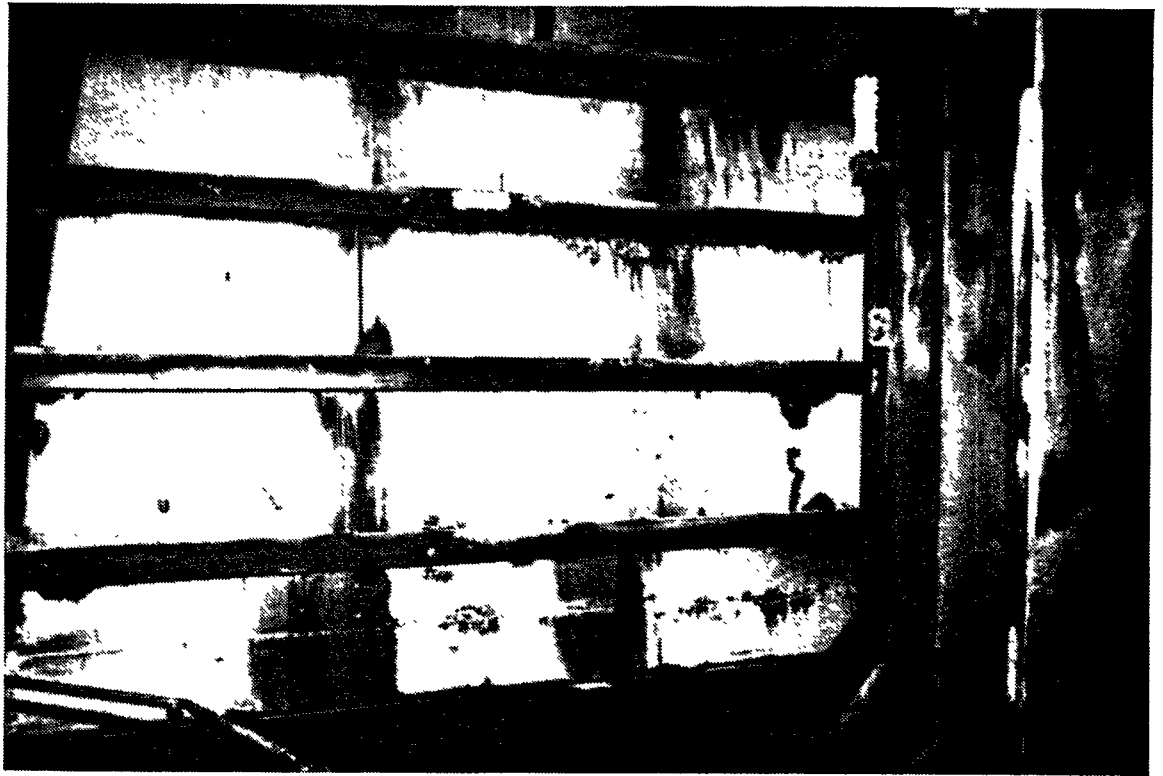
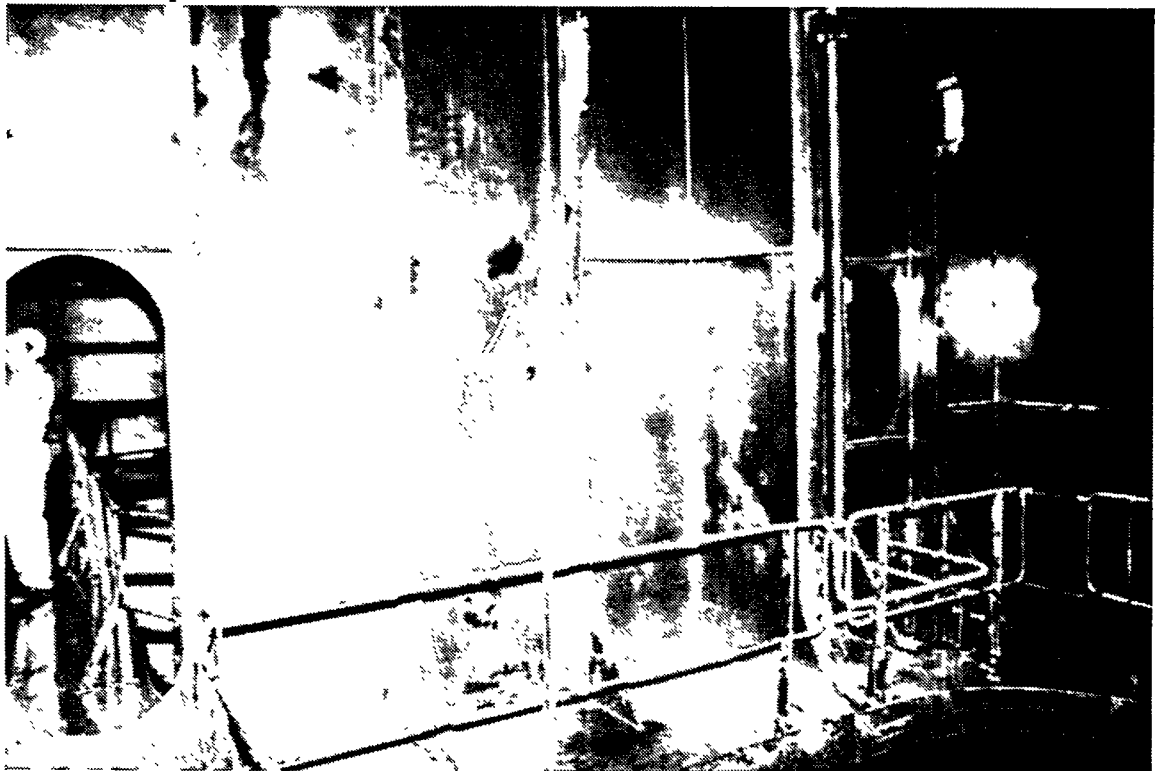
Figure 3.11: Shohi Maru TEAC Tank

The forepeak tank was selected for coating inspection. As opposed to the one year old ship tank coatings, the coatings in this tank were judged overall to be poor. There was extensive corrosion along the bottom edge of the tank top and bottom of the bulkhead where it joins the tank top (See Figure 3.11). One of the tank cells inspected was approximately 10 feet high by 30 feet wide by 20 feet long. This cell was representative of the others inspected. As with the one year ship, the coating system was reinforced with a zinc

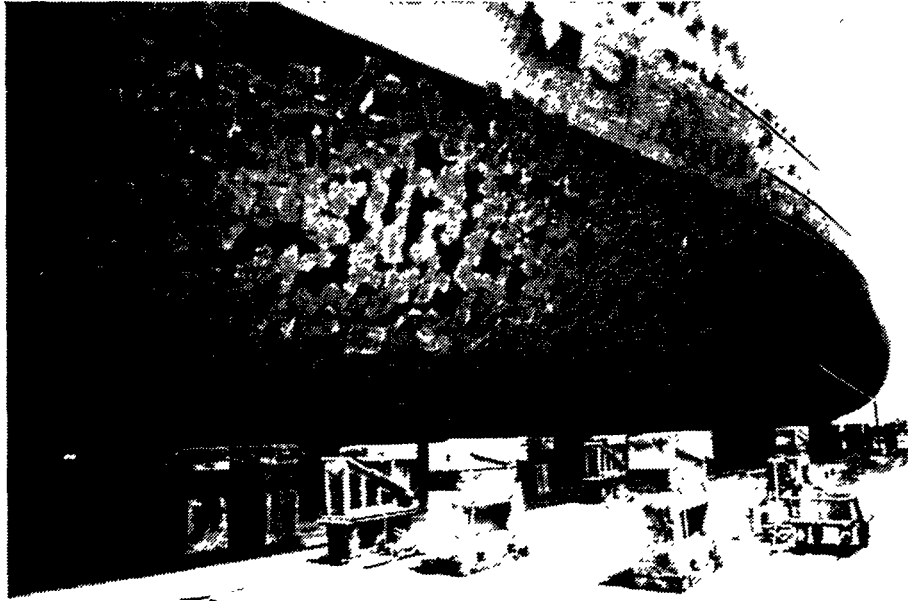
Figure 3.13: Southern Highway Hull

The eight year ship was a car carrier. The primer system is unknown but the entire exterior to include the anticorrosive portion of the underwater bottom is coated with chlorinated rubber. When the ship was being pumped up on the drydock late one afternoon, the general condition of the freeboard was noted to be 5 to 6% coatings failure. There was 1% failure on the superstructure. Some areas had totally delaminated. By the time the inspection crew arrived early the next morning, the ship was up, had been totally washed, sweep blasted and spot primed (See Figure 3.13). The surface preparation and coating activity was a quick hit and miss operation. Measured thicknesses of unfailed coated-areas were as high as 30 mils except for deck areas which were as much as 1/16 inch thick. This probably results from the quick sweep blast and application of additional paint.

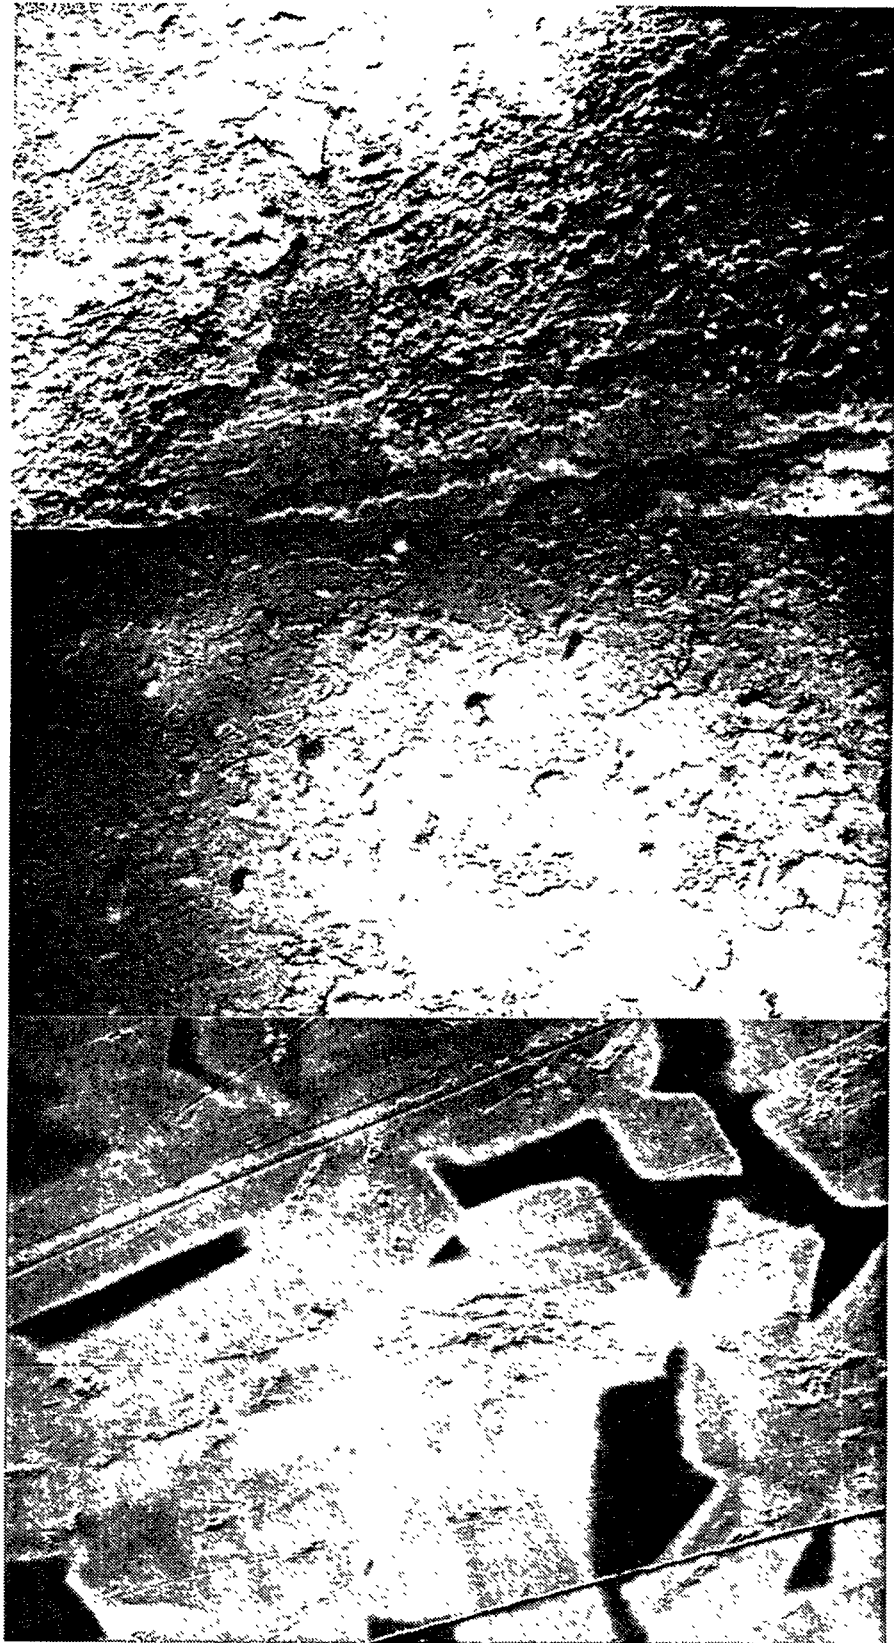
Figure 3.14: Southern Highway

The underwater bottom was not inspected prior to the beginning of surface preparation; however, judging from the amount of touch-up observed the next morning, the bottom probably had at least 50% failure. Figure 3.14 is a close up of the repaired area after spot priming immediately prior to topcoat application. Note that the chlorinated rubber is flaking, appears brittle and is showing signs of delamination. The spot priming and top coats of chlorinated rubber were applied over this condition. The resulting rough condition on the underwater bottom would be unacceptable to some ship owners due to increased fuel consumption.

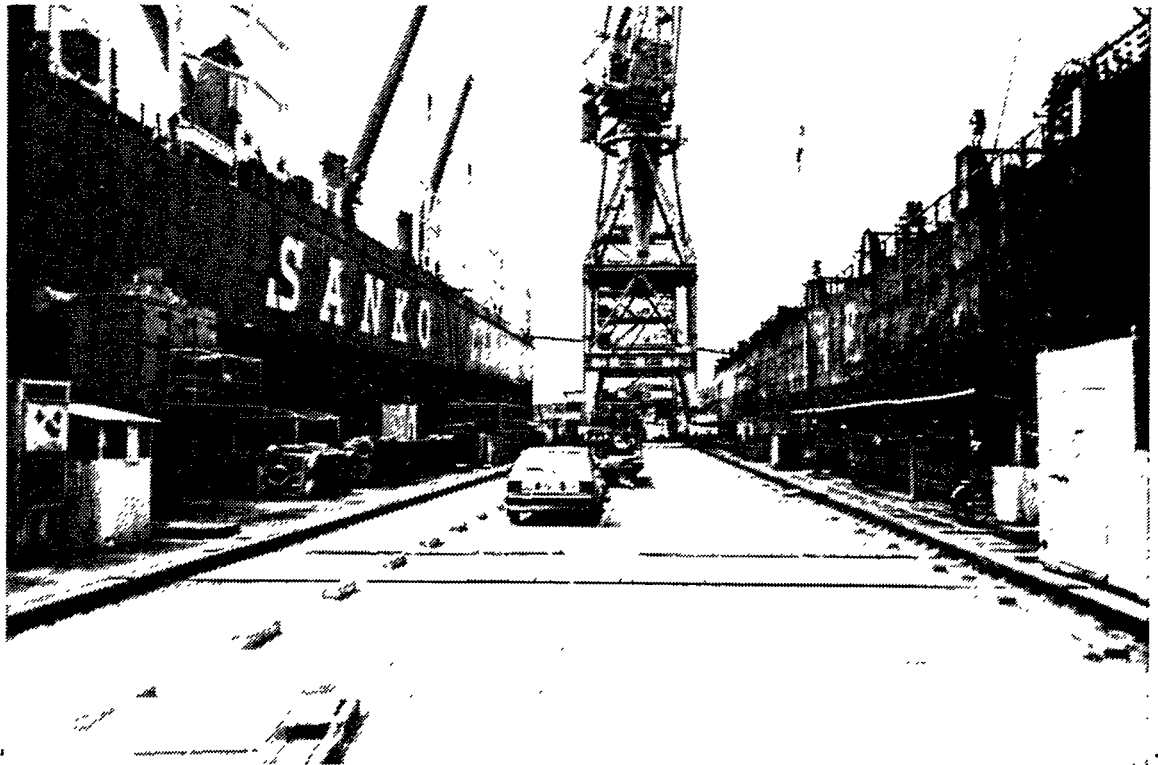
Figure 3.16: Golden Orchid

The ship was originally constructed at IHI Aioi and was inspected at IHI Aioi. As things happen, a new ship of the same type was at dock on the same quay as the surveyed ship. Figure 3.16 provides a good contrast between old and new.

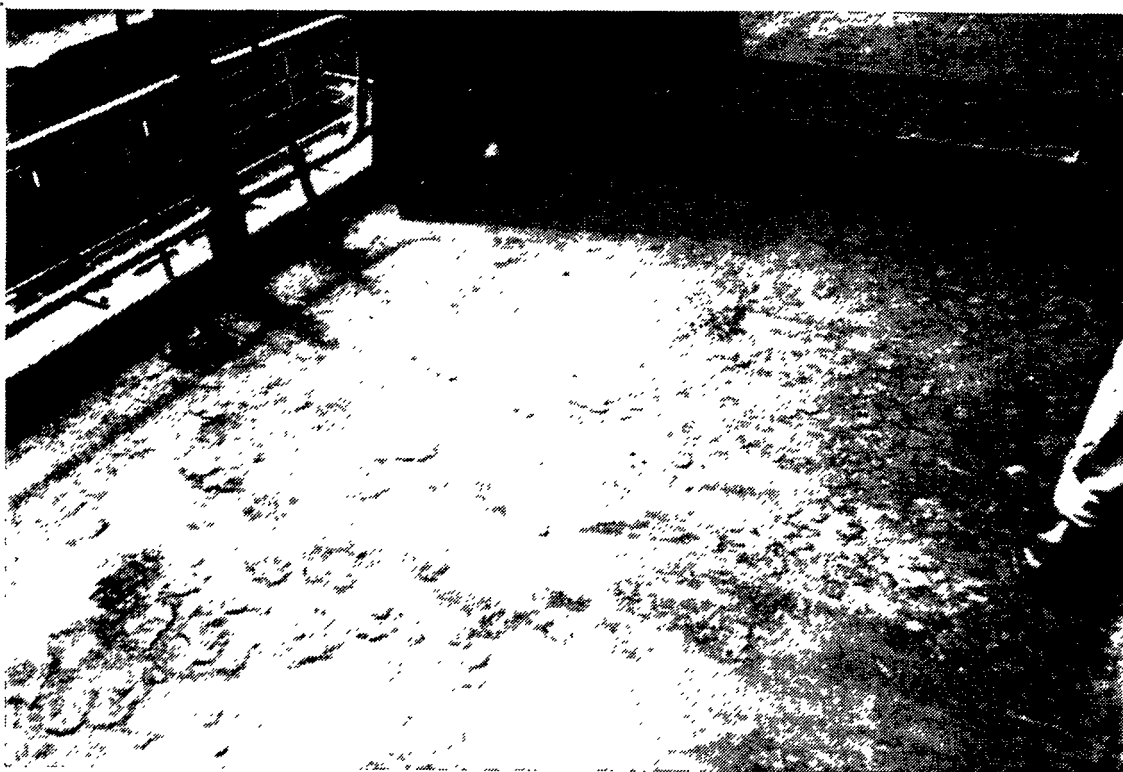
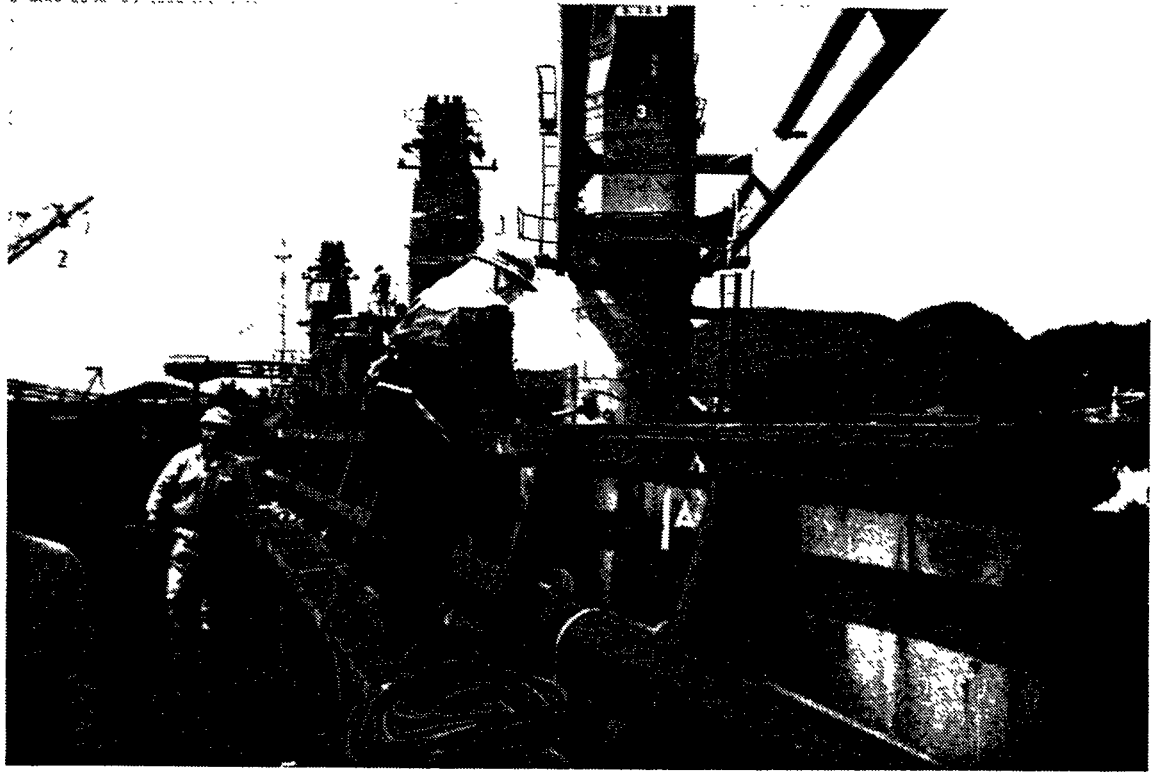
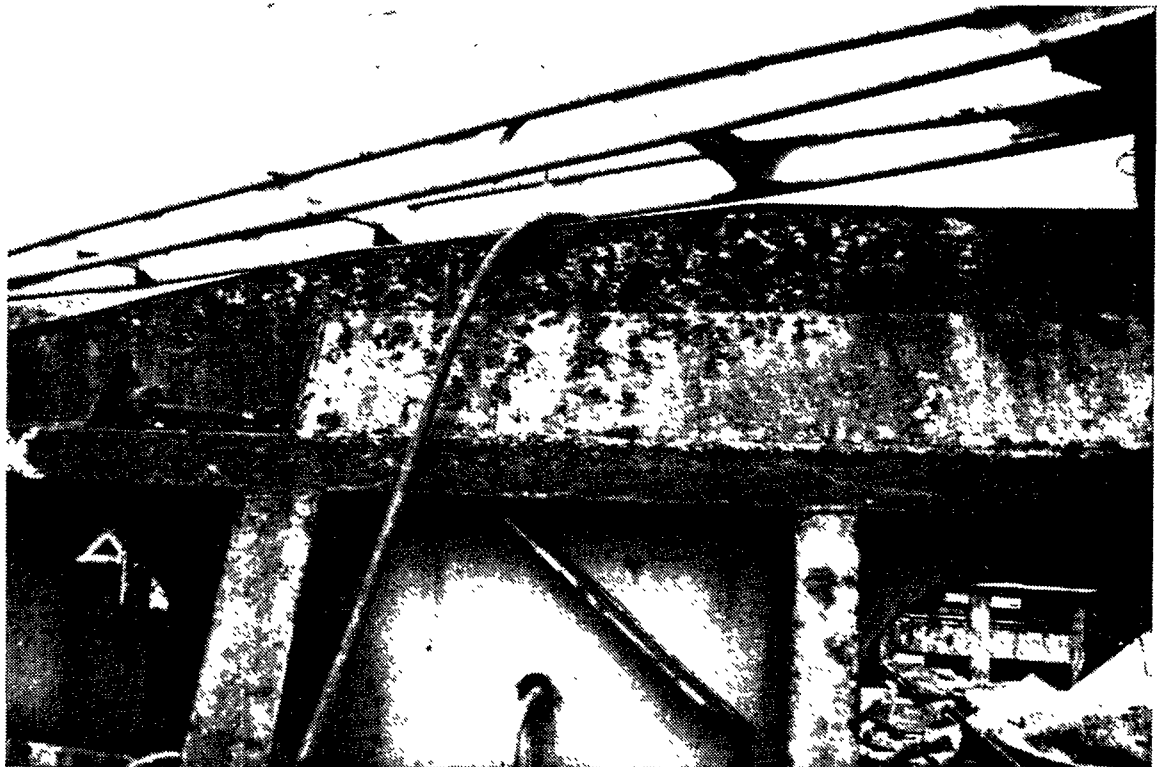
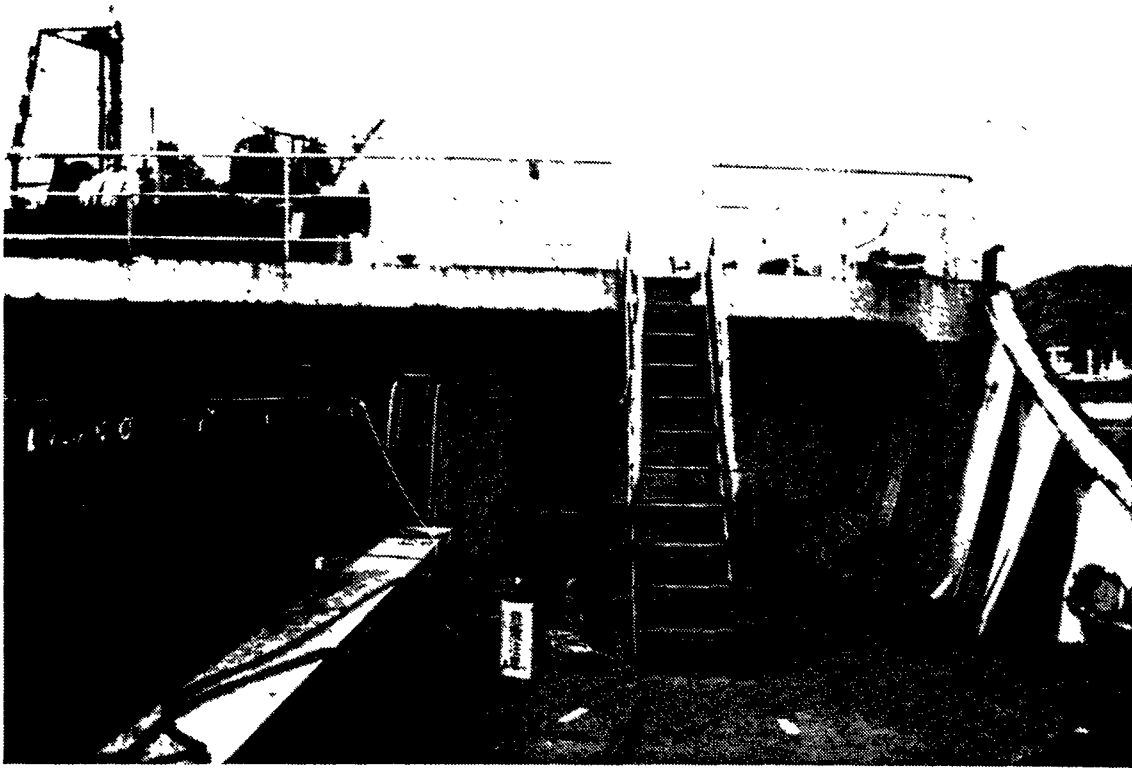
The freeboard had 50% coatings failure with numerous areas of mechanical damage. Some steel side shell plate was being replaced. Deck coatings, hatch coaming, and hatch covers had failed 100% with rust, scale present. (See Figures 3.17, 3.18 and 3.19) Side of the hatch covers had deep pitting and metal loss. Deck machinery coatings failure ranged from 30 to 50%. Cargo hold coatings were approximately 40% failed. (See Figure 3.20) The repair crew was in the process of applying one coat of silver chlorinated rubber over a power tool cleaned surface on the interior of the cargo space.

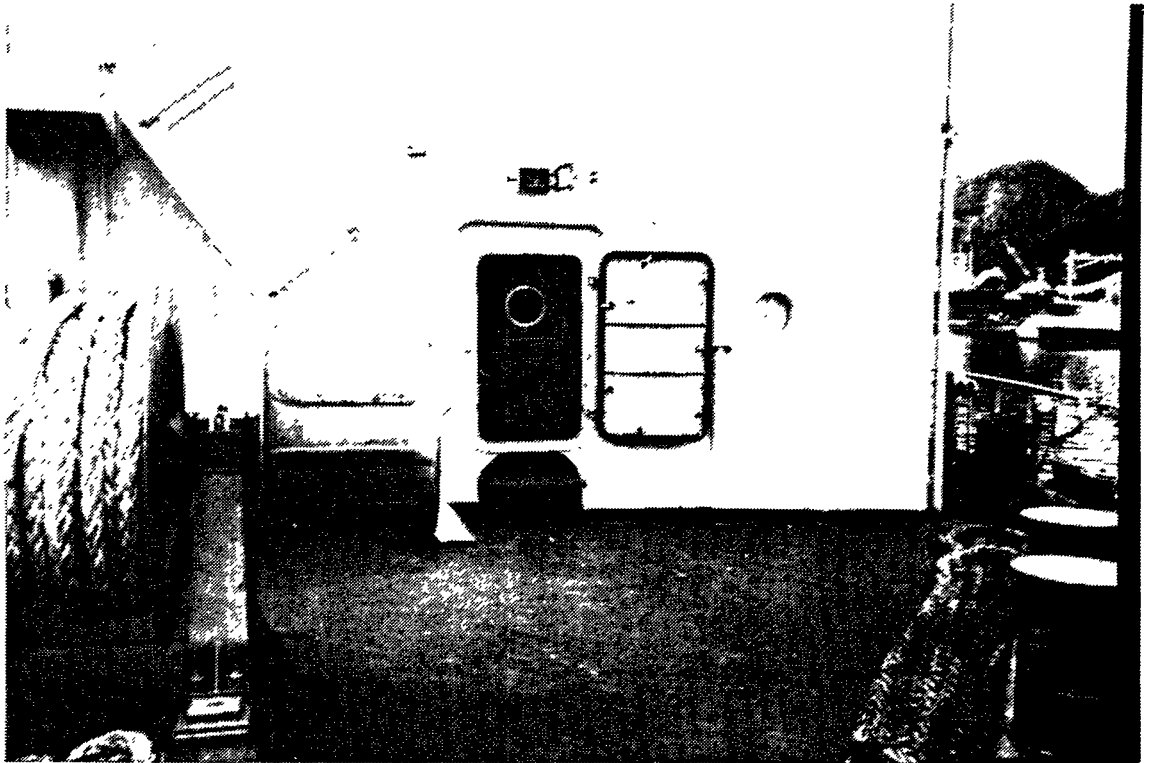
Figure 3.21: Golden Orchid

The interior of the engine room was in excellent condition. The exterior of the superstructure was in good condition and had apparently been painted numerous times. (See Figure 3.21) The measured film thickness ranged from 38 - 40 mils.
